**Air Leak Kit (FlowPro 2.0)**  
**PAGE 1**

This kit should fix any air leaking issues in the **FlowPro 2.0 Digital Series**.

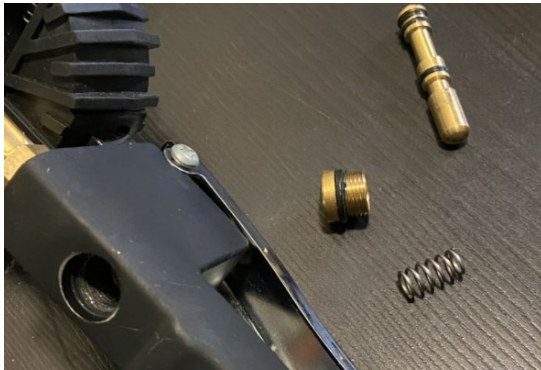
**Step #2** - remove the spring and push the brass plunger out of the unit

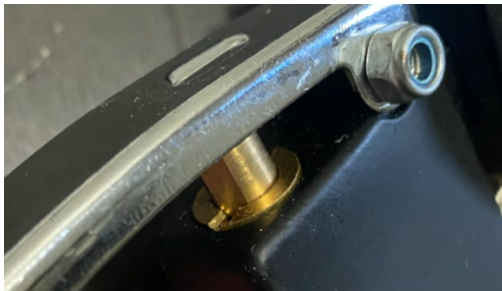
**Step #3** - insert the new brass plunger into the unit by pushing it all the way through the opening slot (flat end of plunger should be facing down)

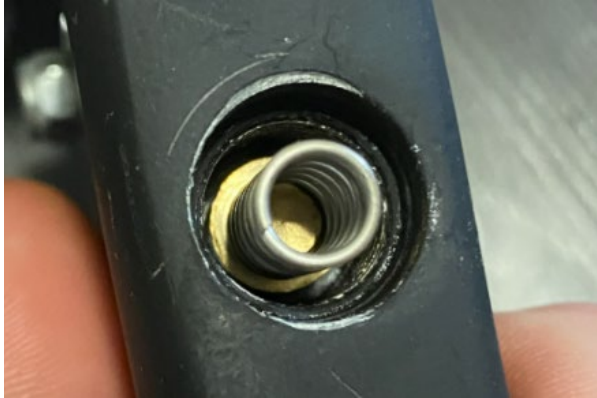
**Step #4** - insert the new spring into the unit by resting the opening of the spring directly onto the circular section on the brass plunger

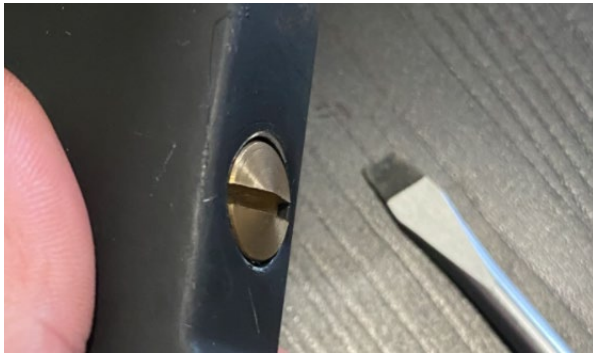
**Step #5** - replace the brass cap screw directly over the spring using a flat head screwdriver, tighten the brass nut cap screw until edges of brass nut screw are flush with inflator handle. **DO NOT OVERTIGHTEN.**

Now, please fill up your compressor tank and connect the FlowPro to your airline and check for leaks. If you are still getting leaks, try to loosen the brass nut screw a quarter turn. Repeat this **at most** two more times, or until the inner spring tension is optimized and there are no air leaks when operating inflator.

**Do NOT remove the brass nut/screw completely while inflator gauge is connected to air compressor line. Only adjust this brass nut/screw in small increments until you do not have any more air leaks.**
